Minor accidents occurred at the Isotope Science Center, the University of Tokyo from FY2020 to FY2023

Contamination of human body with ¹¹¹In and ¹⁷⁷Lu

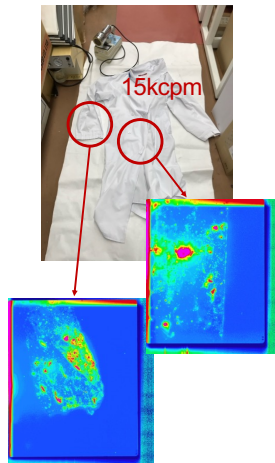
- Contamination was detected on a worker's body after animal experiments using radioisotopes in the radiation-controlled area. After confirming that contamination had been removed through 19 rounds of HFC checks, the worker was able to exit.
- Contamination was not only found on the lab coat worn by the worker but also on the sleeves of the lab coat worn by another.
- An imaging plate was used to examine the contamination of the lab coat, revealing contamination spreading around both sleeves and scattered across the front of body.
- Based on interviews with the workers involved, it was inferred that the cause of contamination spread was due to neglecting to conduct contamination checks on gloved fingers during and after the experiment.
